CHARACTERIZATION OF EARTHEN ARCHITECTURAL SURFACE
FINISHES FROM KIVA Q,
CLIFF PALACE, MESA VERDE NATIONAL PARK
COLORADO

A THESIS

Historic Preservation

1999

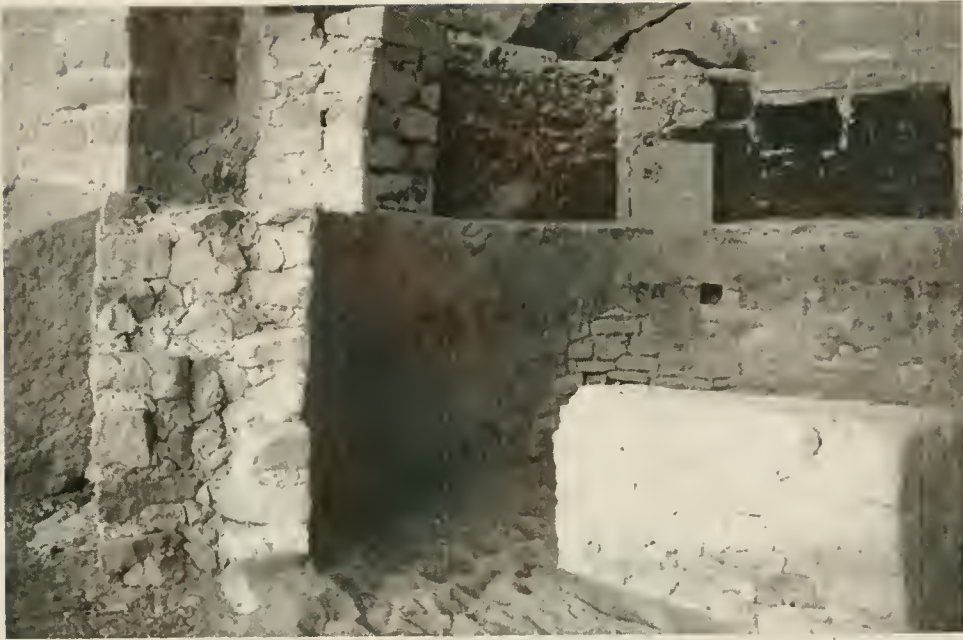
Figure 12. Kiva Q, north wall, deflector.

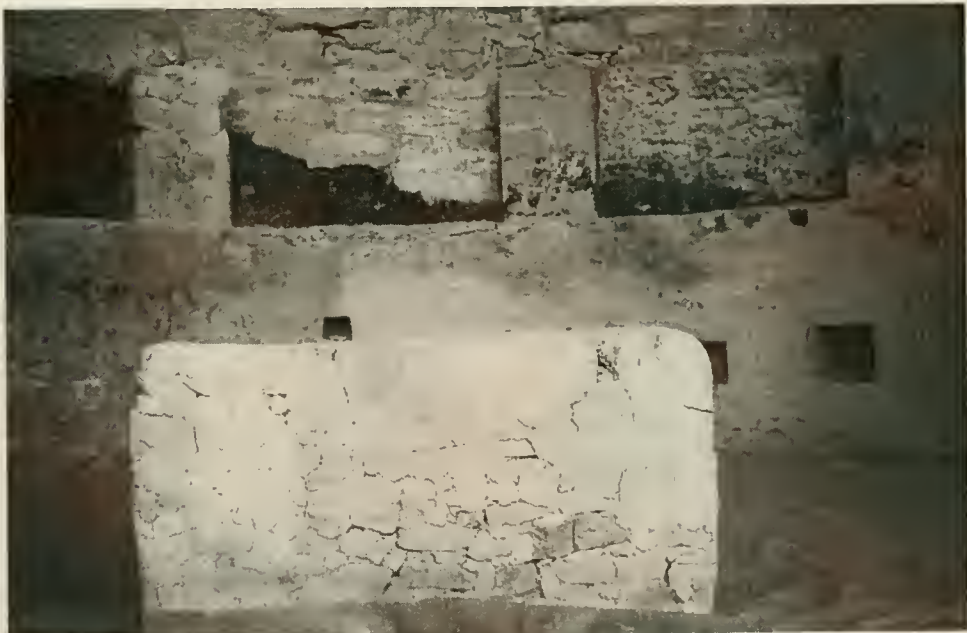
Figure 13. Kiva Q, east wall, deflector.

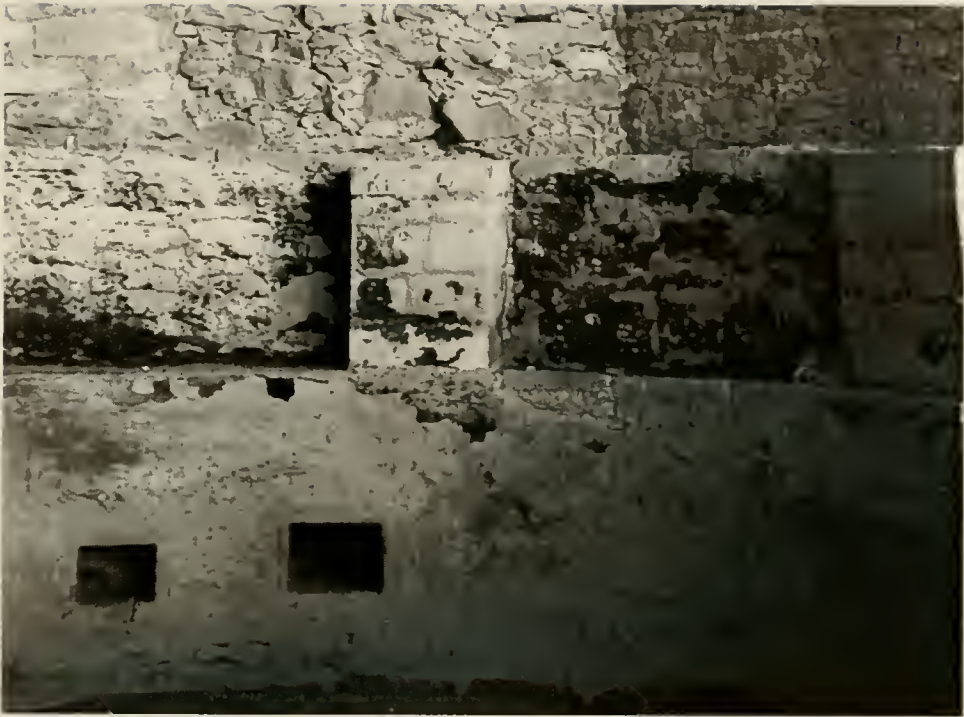
Figure 14. Kiva Q, south wall.

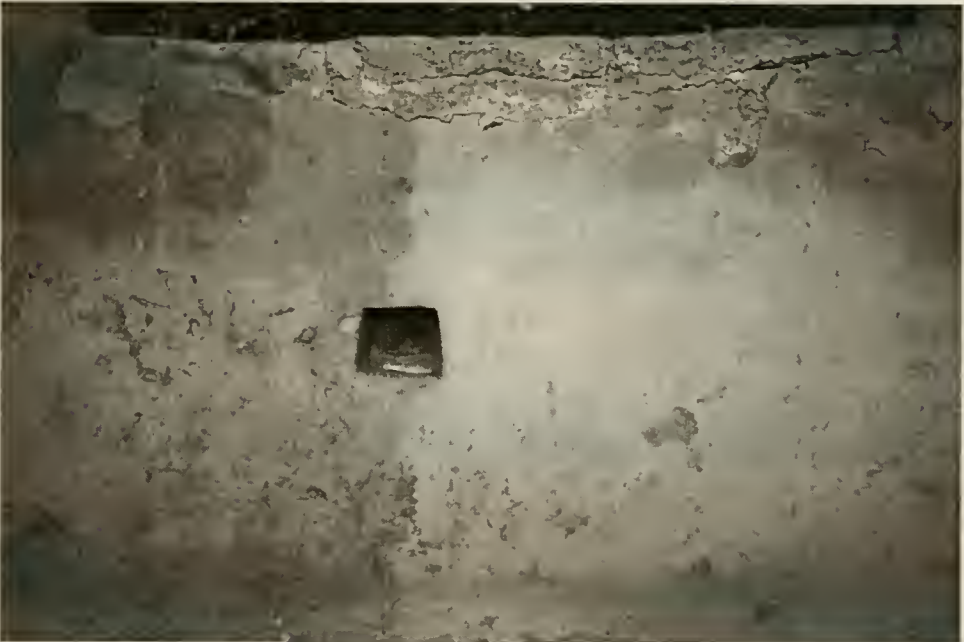
Figure 15. Kiva Q, dividing line in the uppermost finish layer.

The surface finishes of Kiva Q, where extant, vary in condition. The finishes of the south end are in better condition than those elsewhere, but most of the plaster exhibits areas of flaking and detachment from the masonry, as well as delamination between layers of finish. The walls of Kiva Q were finished several times with washes and plasters from earthen materials such as soil and sand, and added color using inorganic and organic colorants to delineate architectural and symbolic elements. The most distinctive feature of Kiva Q observed in the uppermost layer of plaster is a hemispherical division of the kiva running from the top of the banquette to the floor through the center of a niche (Figure 10). This dividing line is created by the interface of the two different shades of reddish-brown plaster used to cover the north and south halves of the kiva. Although the line on the east wall is clear, a corresponding line cannot be confirmed on the destroyed west wall.

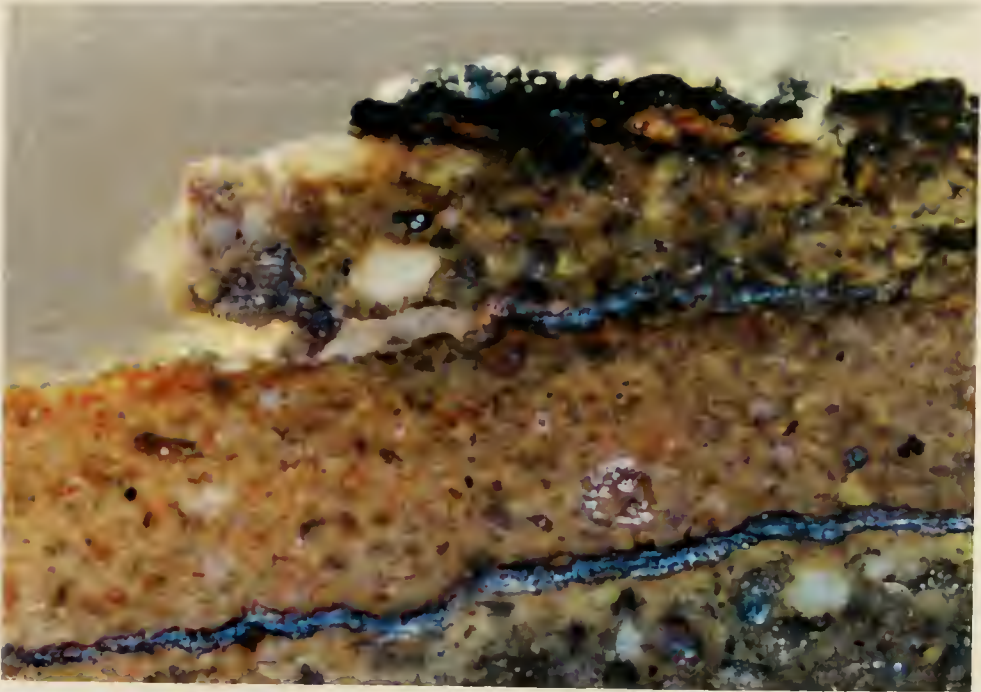
Figure 18. Sample 6 cross section. Reflected light, 10x magnification.

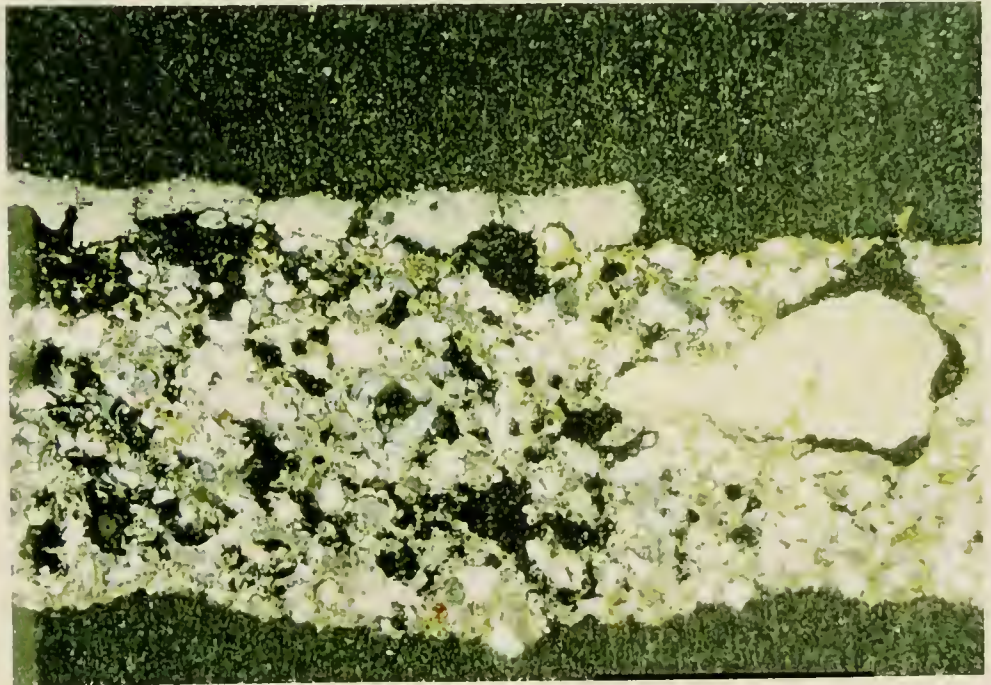
Figure 25. Sample 10 thin section. Cross polarized light, 25x magnification.

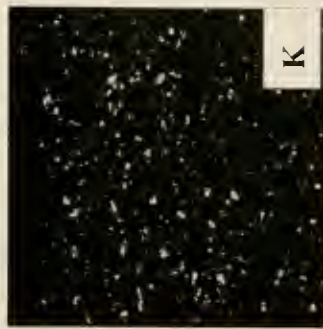
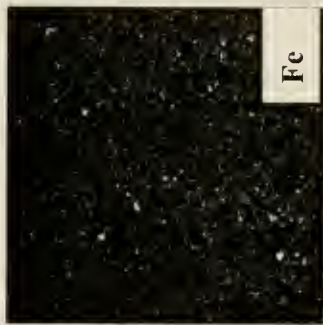
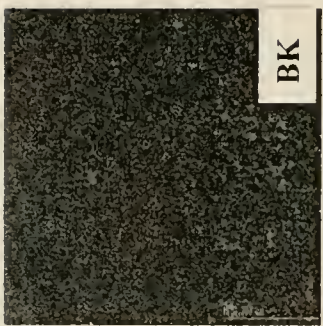
Electron Digital Map
Cliff Palace
Kiva Q
Sample 11

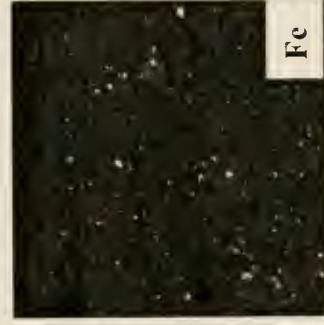
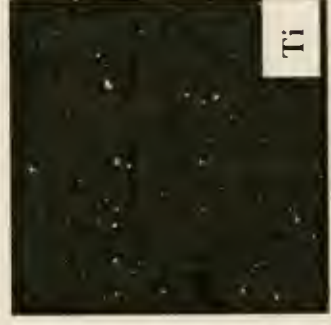
Electron Digital Map
Cliff Palace
Kiva Q
Sample 6

Sulfur- In Sample 6, a bright line in the sulfur map corresponds to a line in the calcium map; this identifies the pigment in the corresponding layer as gypsum ($\text{Ca SO}_4 \cdot 2\text{H}_2\text{O}$), a compound used as a white pigment. This result is puzzling, because there were no white layers observed in Sample 6. The spots on the Sample 11 sulfur map are less distinct, suggesting that gypsum is naturally present in the soil, a finish component, or possibly a result of groundwater contamination.
